# Chapeltown, Leeds

## Conservation Area Extension Appraisal

October 2007

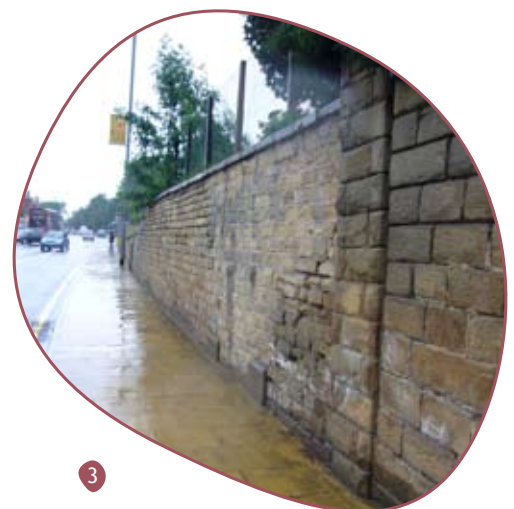
3  
Stone front garden walls

- The presence of sandstone garden walls that front onto the pavements is characteristic of the Conservation Area extension (see Plate 3).
- Although some of the buildings in the south eastern part of the Conservation Area extension pre-date development within the original part of the Conservation Area in Newton Grove, the periods and styles represented by the buildings and the speculative nature of much of the development, are similar to those within the original boundaries of the Conservation Area.

Where stone walls survive these should be retained. A number of stone boundary walls have sustained damage or have been demolished. Repair and, where appropriate, reinstatement will preserve and enhance the character and appearance of the Conservation Area. If the site immediately to the south of Leopold Street, at its junction with Chapeltown Road is to be redeveloped, its front garden walls should be retained and its height and façade treatment should be designed in a manner that is sensitive to its location opposite 101-117 Chapeltown Road and at the southern gateway to the Conservation Area.

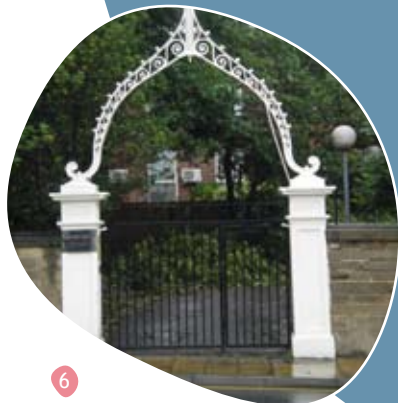
6

Prominent and interesting features include the wrought iron gates to 126 Chapeltown Road (see Plate 6), the views of the Listed elements of the Northern School of Contemporary Dance, views of the frontage of the Holy Rosary Church and of the older houses. A small plaque (possibly for fire insurance) set against the boundary wall at the front of 1 Leopold Street, on Chapeltown Road is of historic interest (see Plate 7).

Wrought iron gates of 126 Chapeltown Road

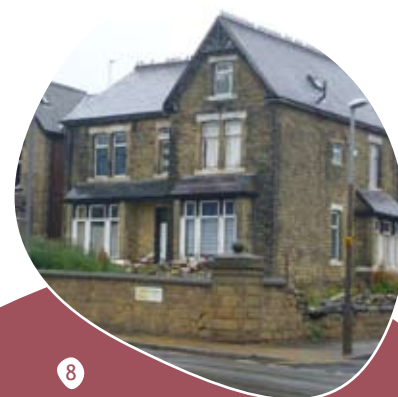
8

The houses along the east side of the road, north of Cowper Street, were built at the same time as the housing to the east. They are two storeys high, plus attic, have sandstone façades facing onto the main roads, with brick rear elevations, and have slate roofs. The rows of houses are punctuated by gables, with attic windows, facing onto the road. The gables originally had decorative bargeboards with decorative bracing (see Plate 8). In many cases these have been replaced with simpler barge boards. The buildings originally had stone front garden walls which harmonised with the earlier garden walls to the south. Where the buildings have been converted to shops, at the north end of the Conservation Area extension, the front gardens have been removed. The houses have ground floor bays beneath catslide roofs that extend over their front doors and their upper floors are characterised by having paired sash windows and their stone façades harmonise with the garden walls and other buildings in the Conservation Area. Some of these buildings are in very poor condition and in some instances have been gutted by fire (see Plate 9). The roofs of these houses originally had decorative ridge tiles and in a few cases these survive intact. Most have been replaced or are damaged.

Houses on east side of Chapeltown Road. The original bargeboards survive. The garden wall has suffered damage.

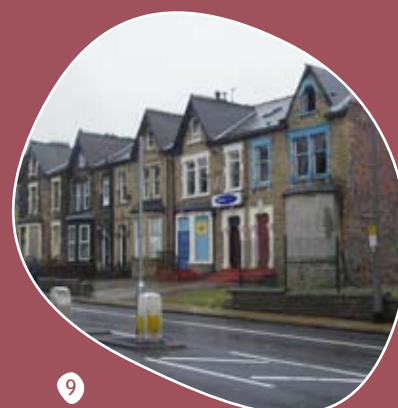
9

Vacant, damaged houses on east side of Chapeltown Road. In some cases the original ridge decoration survives on the roofs.

There is some vacancy in the ground floor shops in the shopping parades on Chapeltown Road and in the offices/flats above. A number of houses on the east side of Chapeltown Road, towards the north end of the Conservation Area extension, are empty and in very poor condition (see Plate 9). Four of these houses have already been demolished. Further demolitions should be resisted and opportunities for finding economic uses for these buildings and filling the vacant premises should be sought.

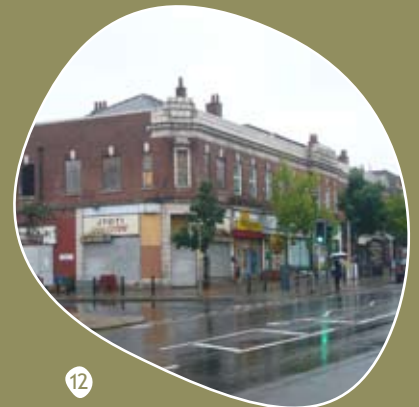
12

195-211 Chapeltown Road. Much of the building is vacant

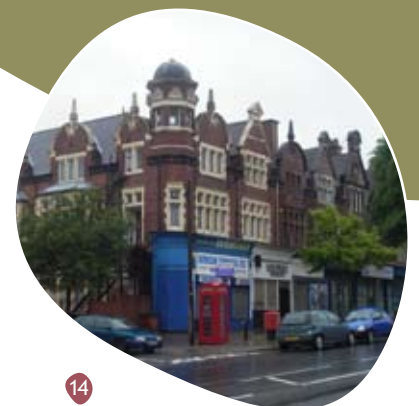
14

213-229 Chapeltown Road. Except for the shop fronts the terrace has changed little.

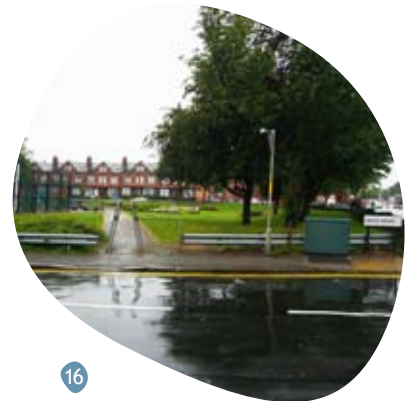
16

The recreation ground and the two storey red brick housing to its north and south on Savile Drive and Savile Mount, within the Conservation Area extension, were laid out and mostly built between 1893 and 1908 (see Figures C and D). The slope of the hill from east to west and from north to south was addressed by designing the recreation ground as a series of terraces, with the east end higher than the west and a significant difference in height between the western part of the recreation ground and Savile Drive and Savile Mount (see Plate 16).

Buslingthorpe Recreation Ground viewed from Savile Mount showing the terracing on the hill.

Removal of the crash barriers around the recreation ground would represent an enhancement of character.

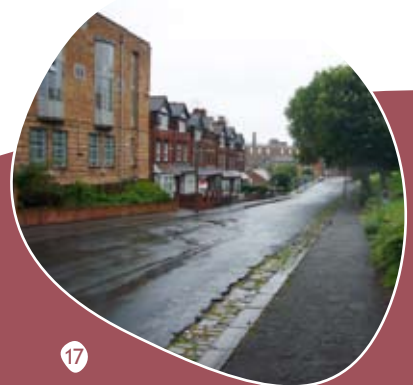
17

The Art Deco Host Media Centre, with its prominent two storey upper floor oriel, is a significant element of the historic character of the roads around the recreation ground and is of architectural and historic interest in its own right. There are areas on Savile Mount where setts are visible in the gutters at the sides of the road (see Plate 17). These are historic features and should be left uncovered and weeds removed.

Savile Mount, showing the original setts in the guttering and part of the Host Media Centre

Some roads, surfaces and areas of setts are poorly maintained. Weeds should be removed from gutters and the carriageways better maintained.
