Collingham is a place of special character and historic interest.

# Conservation area appraisal AND MANAGEMENT PLAN

Approved as a material consideration in the determination of planning decisions—22nd February 2010

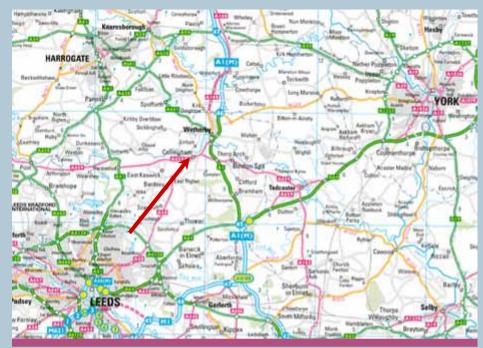
Collingham in its wider context

The Collingham Conservation Area retains a strong independent character with regards its landscape setting. To the south and east of the conservation area the rising escarpment forms a distinctive landscape boundary, and to the north open green land and meadows, and the River Wharfe, form a second strong boundary. Surrounded by countryside and modern housing developments, the conservation area has a strong historic survival in a village dominated by later 20th century developments.

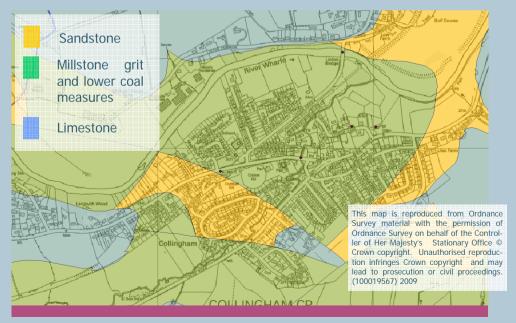
The solid geology of Collingham

The settlement is located on a mixed solid geology, with Millstone Grit and Limestone both having an influence on the landscape, and also a strong influence on the built environment.

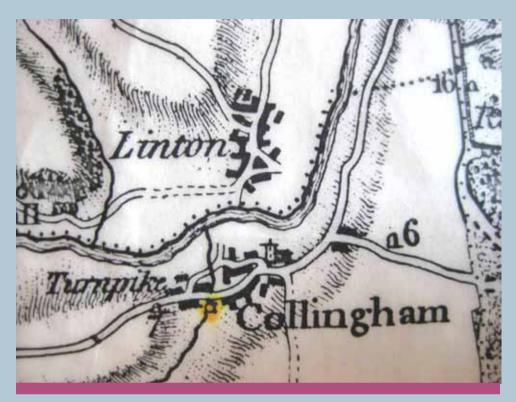
Thomas Jefferson's map of 1775 shows Collingham to be a built up location. Note that at this time there appears to be no School Lane (or Back Lane as it was previously called).

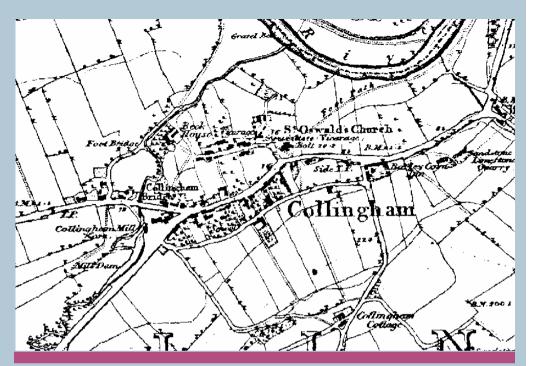
First Edition Ordnance Survey map of 1847. The modern A58 was now n place, with the focus of development appearing to move to its junction with Main Street.

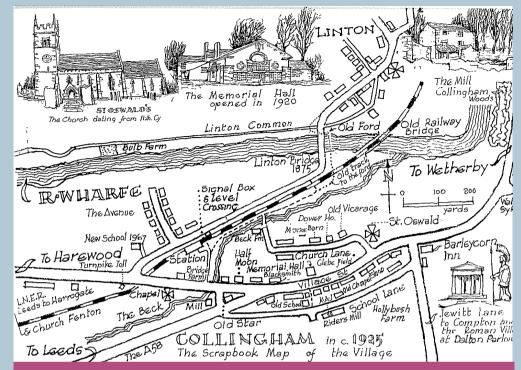
A map of Collingham c.1925, before it was consumed by housing developments. This map was taken from Collingham-A Village Scrapbook by Ken Jones (reproduced with permission of the artist-Denis Mason Jones).

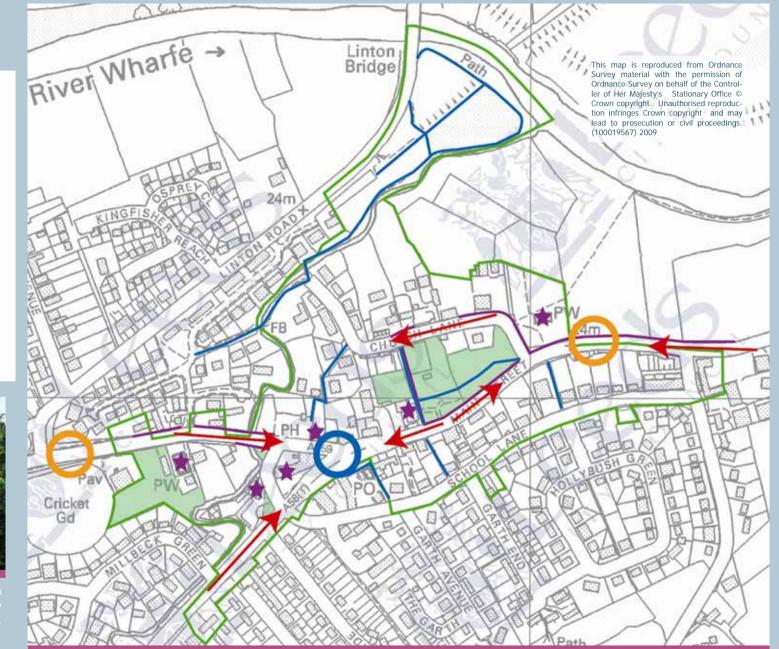
The important green areas within the centre of Collingham are key to the character and the development of the area

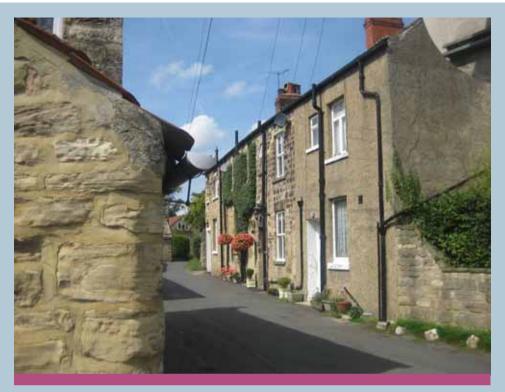
The buildings on Church Lane are historic, and on the whole very simple in appearance and detailing.

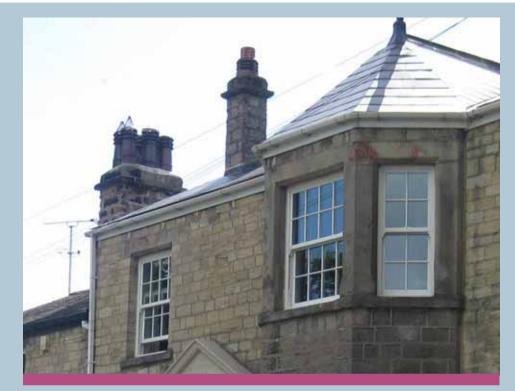
Historic windows, regularly coursed sandstone and chimneys are all traditional architectural elements which are positive to individual structures and the building stock as a whole.

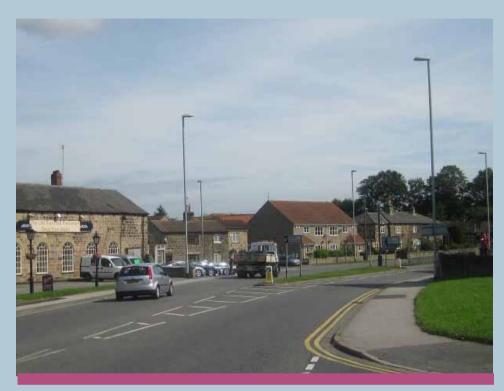
The junction of the A659 and A58 is the centre of activity in Collingham. The streetscape is not as sympathetic as other parts of the village, due mostly to the street furniture installed to cope with the large volume of traffic.

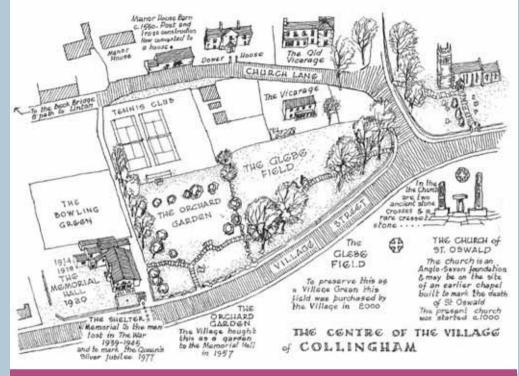
This sketch map by Denis Mason Jones shows the importance of Orchard Garden and The Glebe Field as central green areas in Collingham

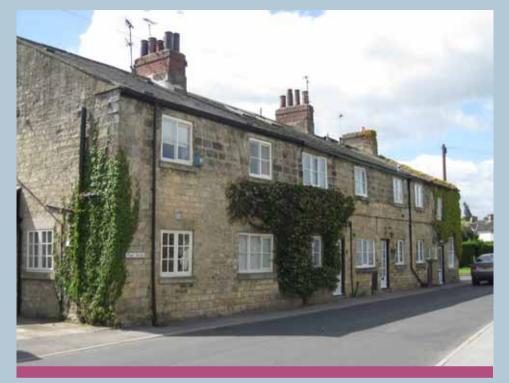
Any new buildings should be in-keeping with the existing historic architecture within the conservation area. Key architectural characteristics and materials should be referenced from the buildings to ensure new developments are sympathetic with their surroundings.

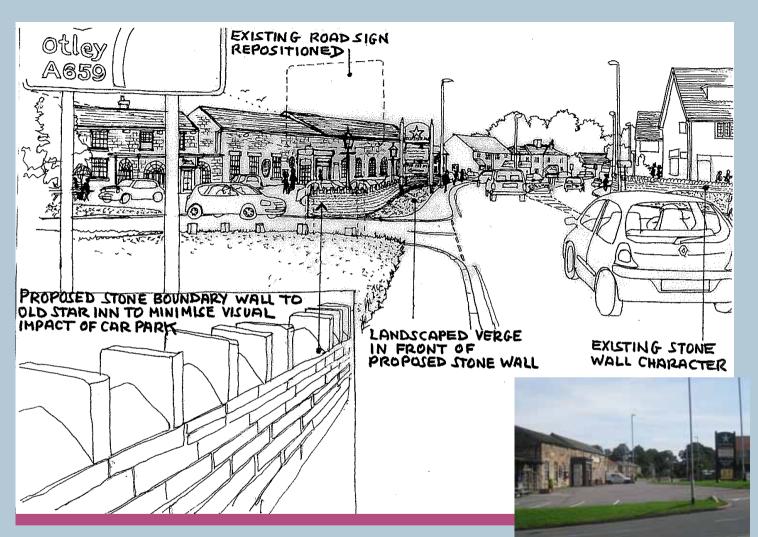
Sketch of how Main Street, Collingham could benefit from screening of the open car parking. The use of simple boundary walls and landscaped verges, as seen on the aspirational drawing above, would improve the character and appearance of this area.

# The screening and sympathetic treatment of exposed car parking on Main Street and Harewood Road

When entering Collingham village centre from the west there are some major areas of unscreened parking which have a negative impact on the character and appearance of this part of the conservation area. The parking in front of The Old Star Inn and the service yard to the rear, the area in front of the shopping complex, and the car park of The Half Moon Inn all contribute to an unsympathetic appearance of Collingham. Tree planting, soft landscaping and stone boundary walls could all lessen the impact of the parking and enhance the special character and appearance of the conservation area.

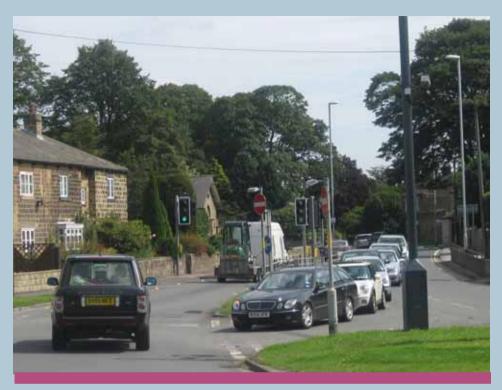
Main Street is the area which suffers the most at the hands of public realm. More sympathetic installations would help to preserve and enhance the character of the area and should be implemented when the opportunity arises.

- The traffic island located on Main Street is in need of enhancement and sympathetic alteration. Whilst the necessity of the island is acknowledged, it is not in keeping with the special character and appearance of the conservation area.
- Appropriate treatment for street furniture (streetlights, benches etc). An example of this is the painting of the street lights black to make them
